Structural Evaluation of Pipe Leg Tower and the Engineering and Execution of Controlled Demolition of Guyed Towers

Presented By: Shawn Knotts
Western Region Account Manager
Electronics Research, Inc.

Subject Project:

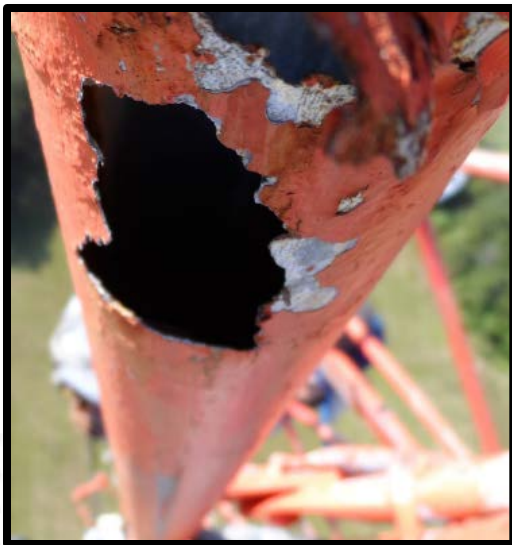
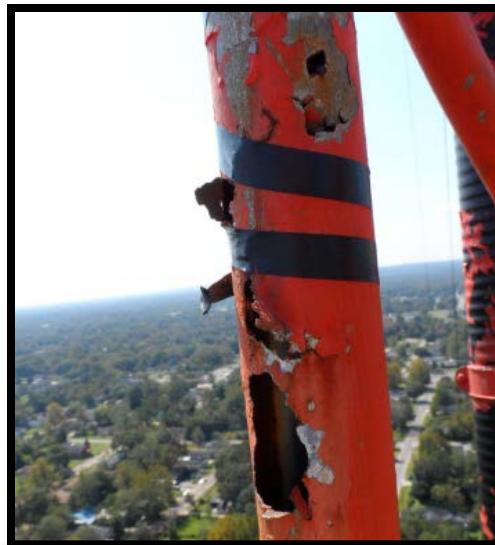
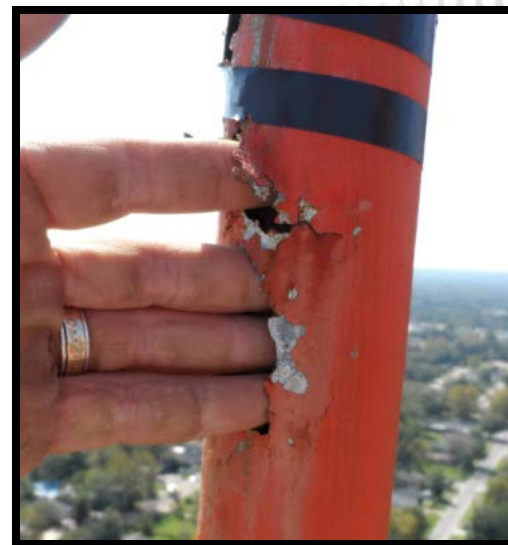
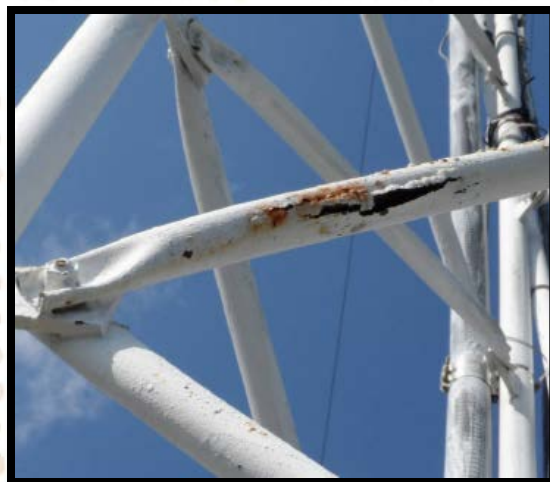
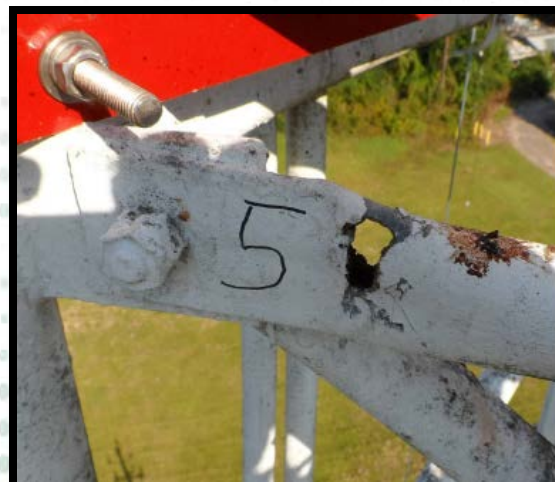
- 490' Guyed Tower Located in Congested Residential Area (6 Guy Levels/50% Guy Radius)
- Local Crew Noted Severe Corrosion While Preparing to Rig Tower for an FM Install
- ERI Conducted Initial Climbing Inspection and Condition Assessment
- Performed Deterioration Analysis of Tower in Accordance with TIA-1019-A
- Prepared Engineered Rigging Plan to Safely Deconstruct Mast ~ Controlled Drop
- Executed Plan With Onsite Engineering Supervision

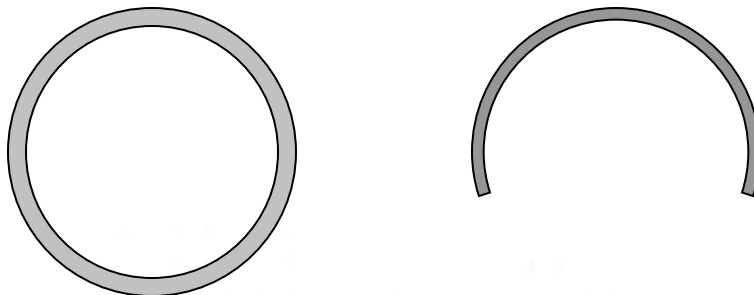
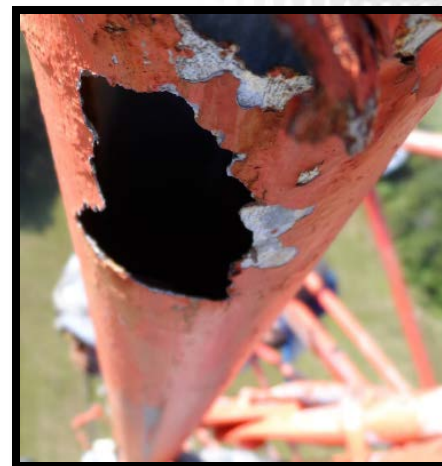
*Reduced Buckling Strength Calculated

Strength Reduced by Over 50%!!!

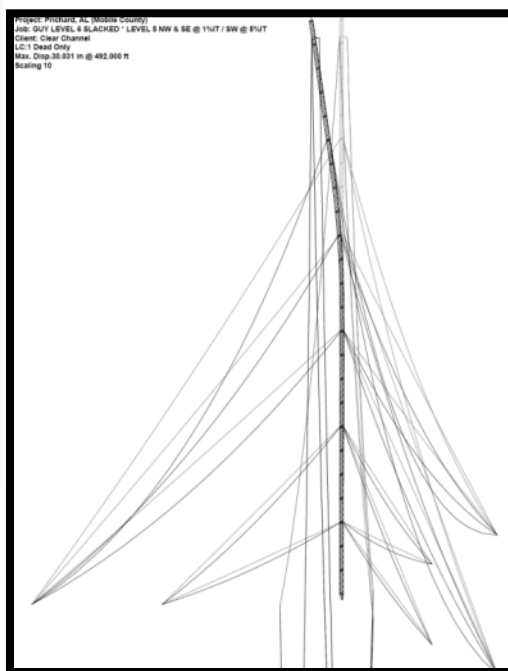
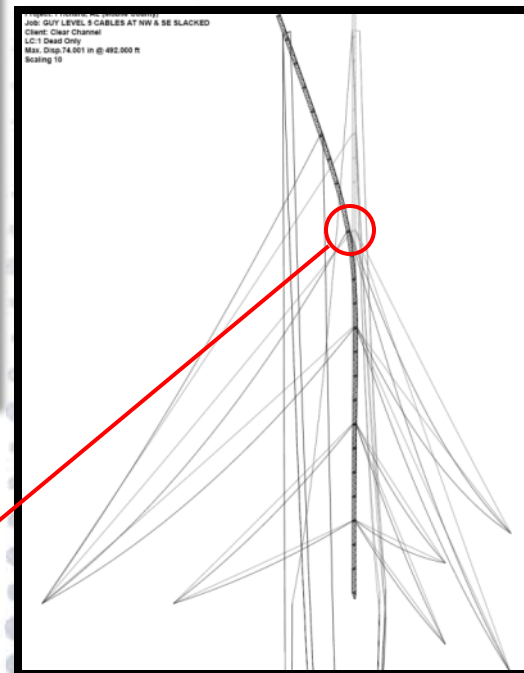
Location of Most Severe Corrosion
Engineered to be First Yield Point
*Direct Fall of Top 180'

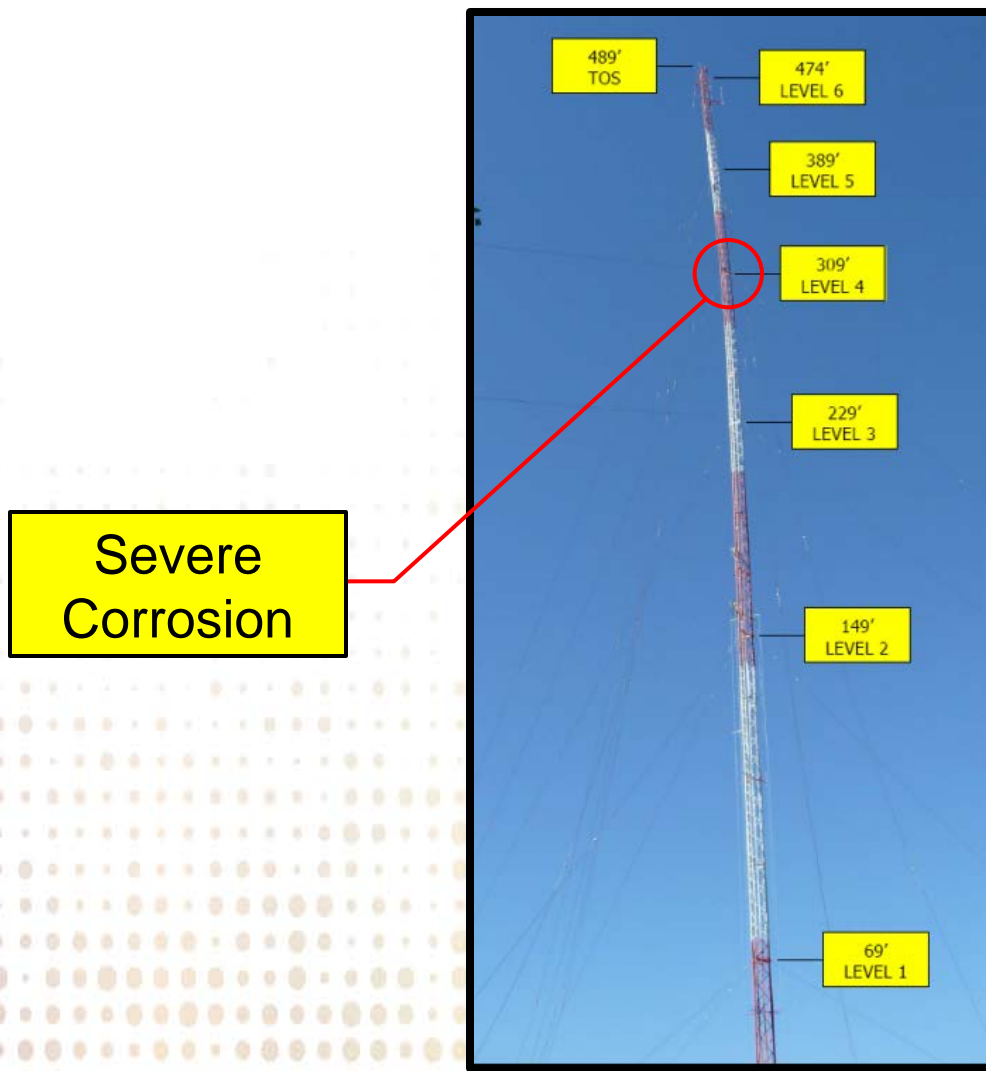
Relaxation & Removal of Pre-Determined Guy Cables in a Sequential Order Based Upon Results of Dismantle Analysis

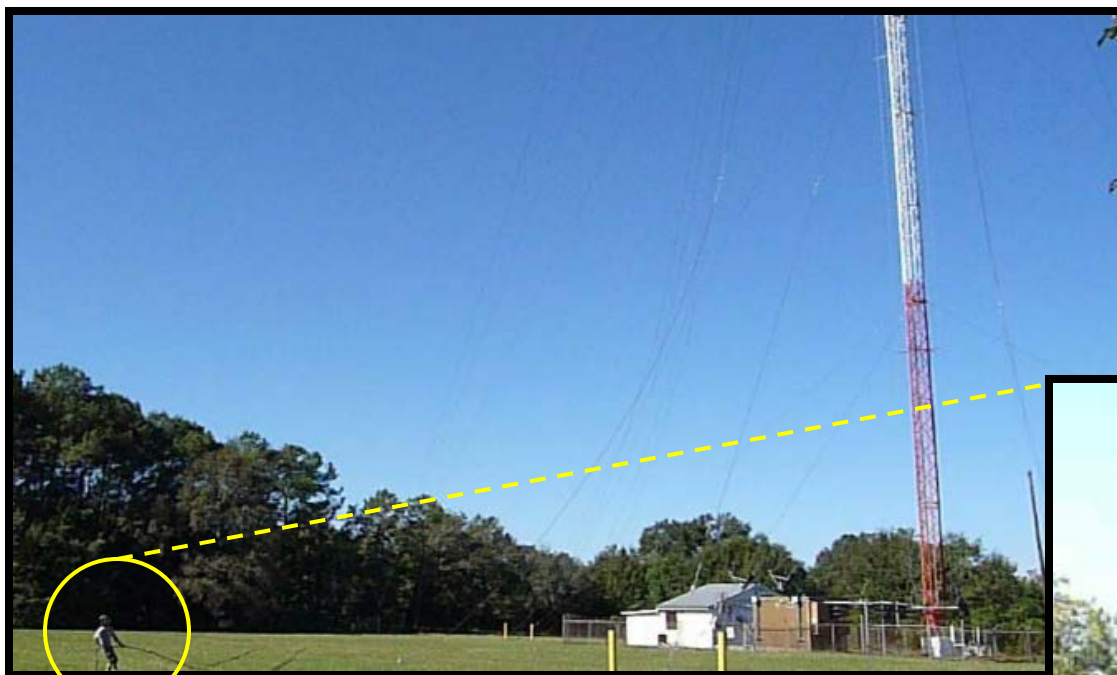
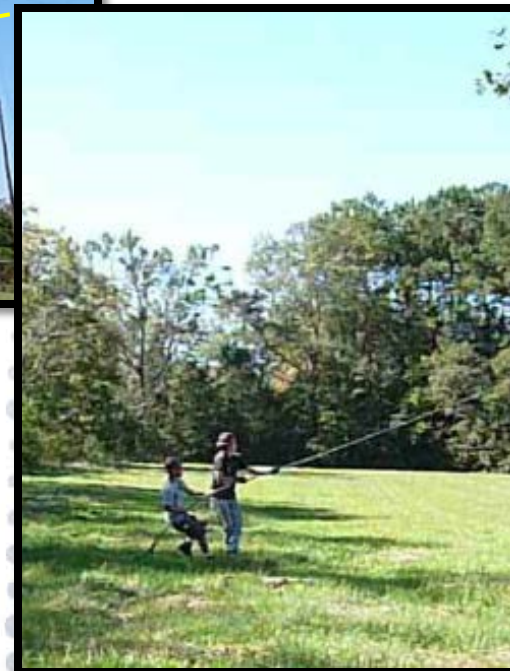
Certain Guy Cables Were Disconnected From Anchors While Others Remained Intact Until The Critical Failure Point Was Reached

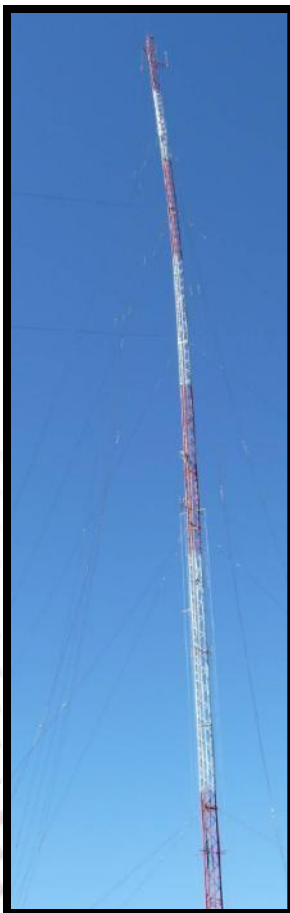
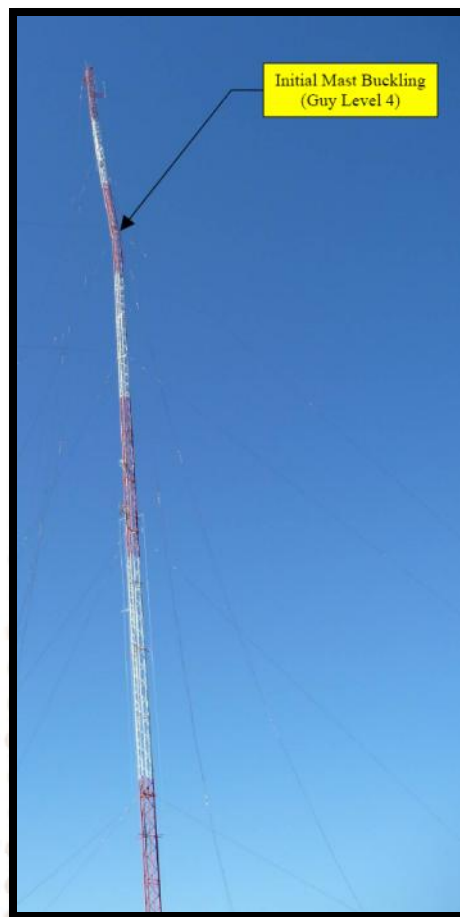
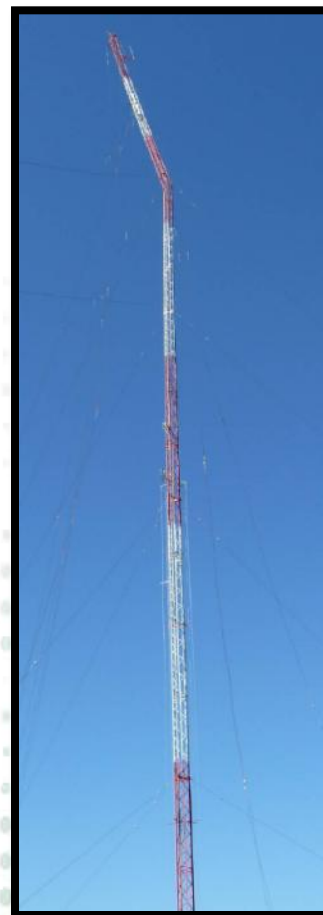
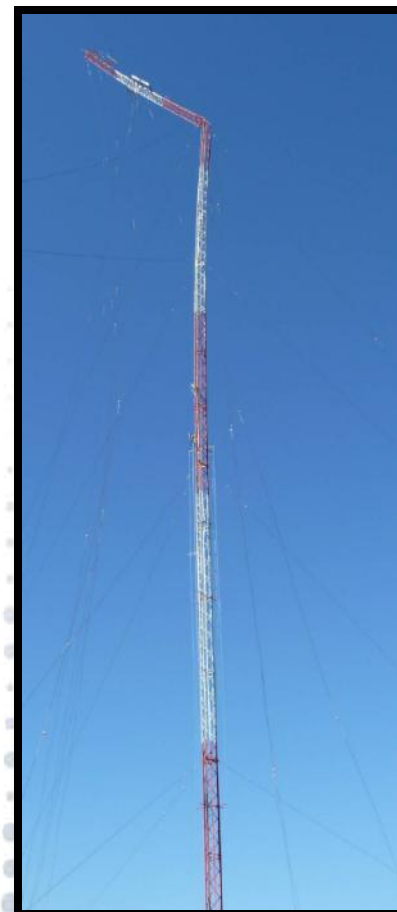
Initial Fall Sequence:

Matched Analysis Results

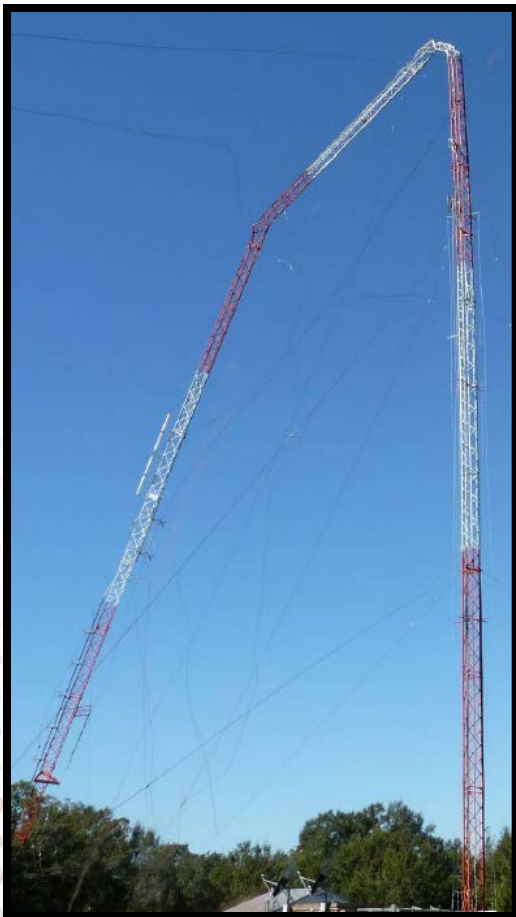
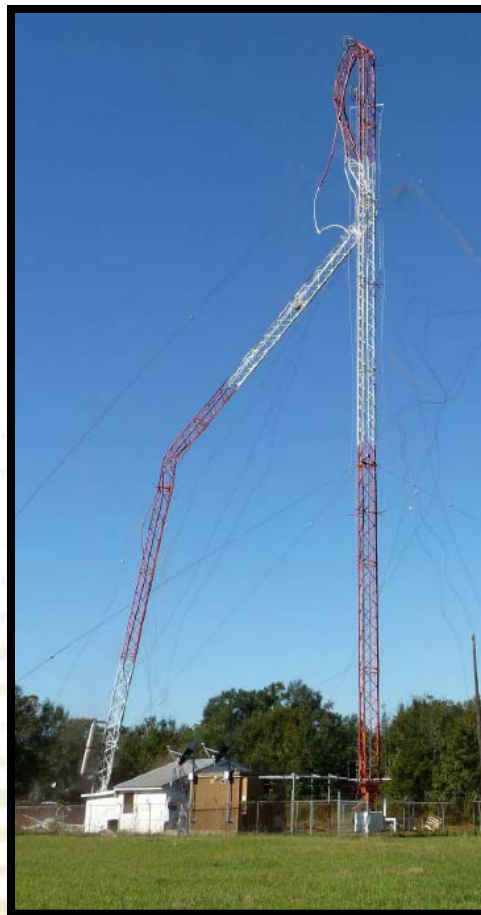
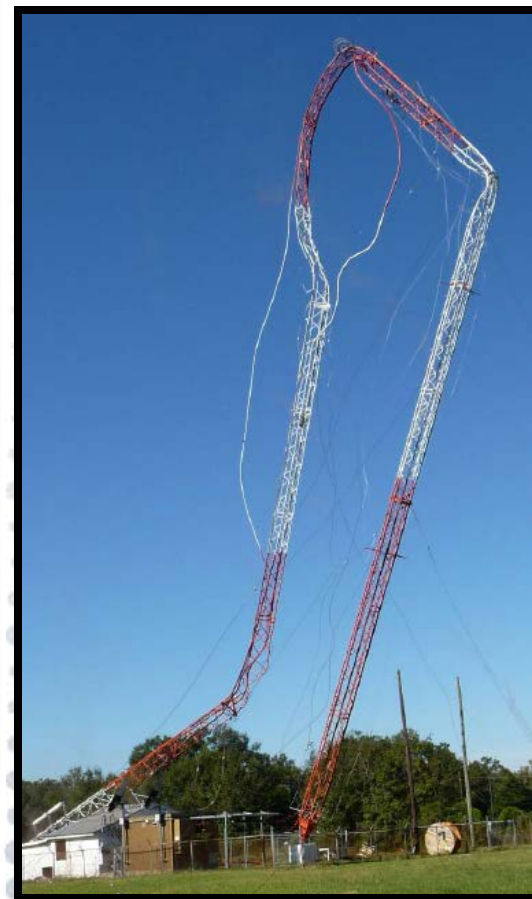
Secondary Collapse Mode:

Difficult To Predict!
Important to Control Initial Descent

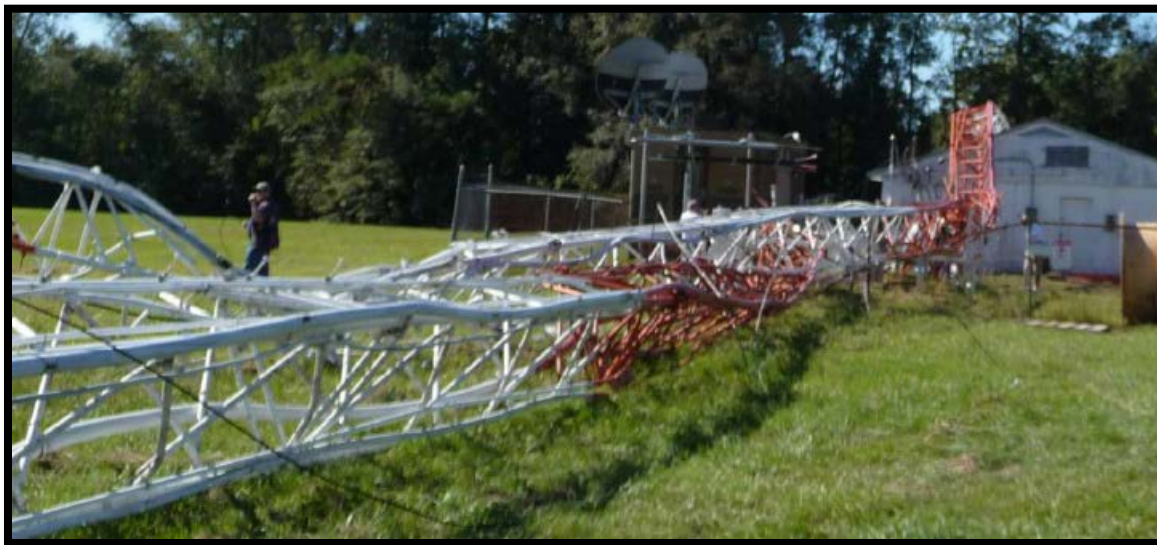
*Tower Collapse Directed Towards SW Guy Path

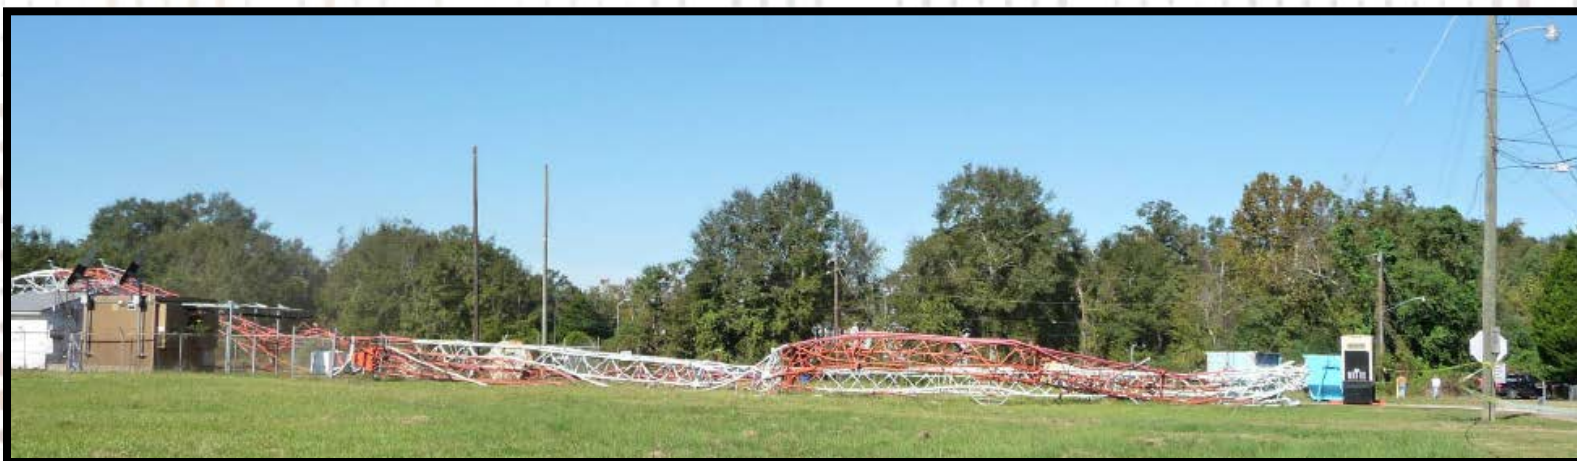
*Fall Radius Limited to ~125'

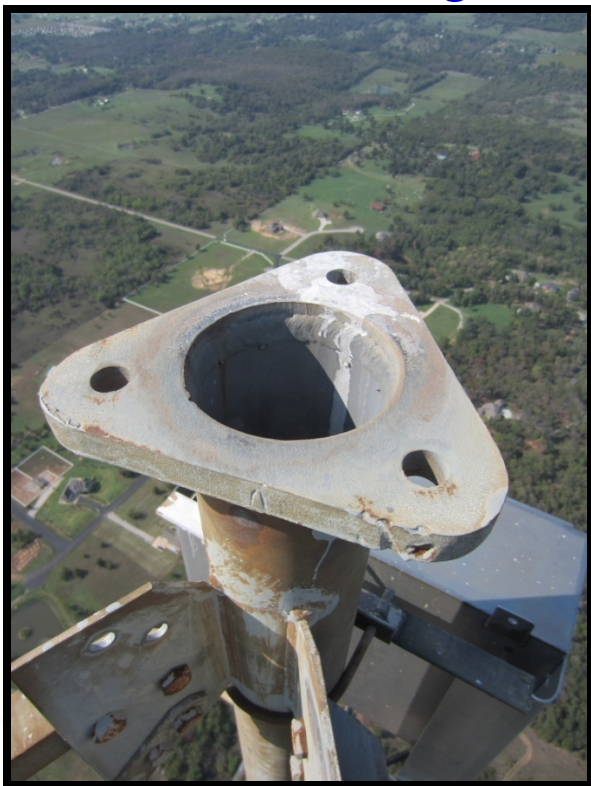
*Recessed Design ~ Good Drainage

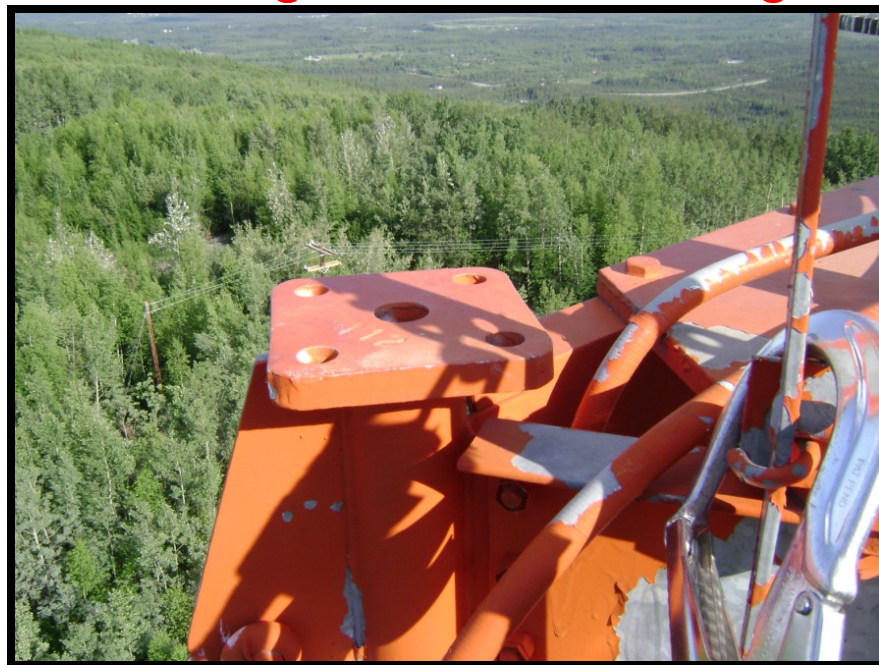
*Butt Design ~ Poor Drainage

*Pickling Acid Does Not Fully Drain Which Can Result in Poorly Coated Areas

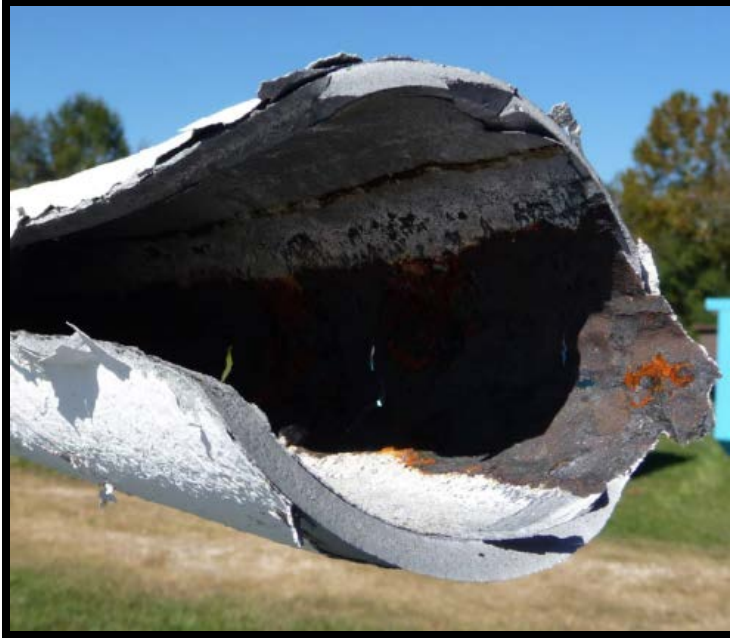
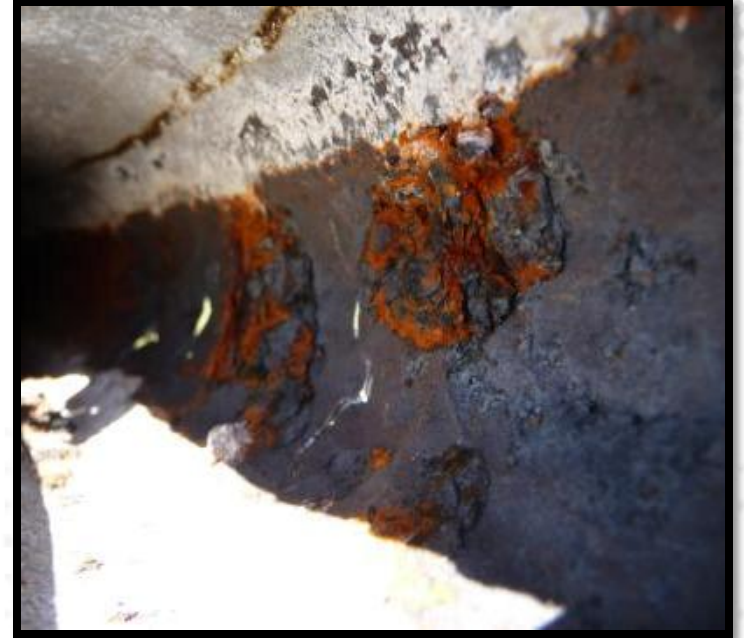
Galvanizing **NOT** Uniformly Deposited on Internal Portions of Pipe

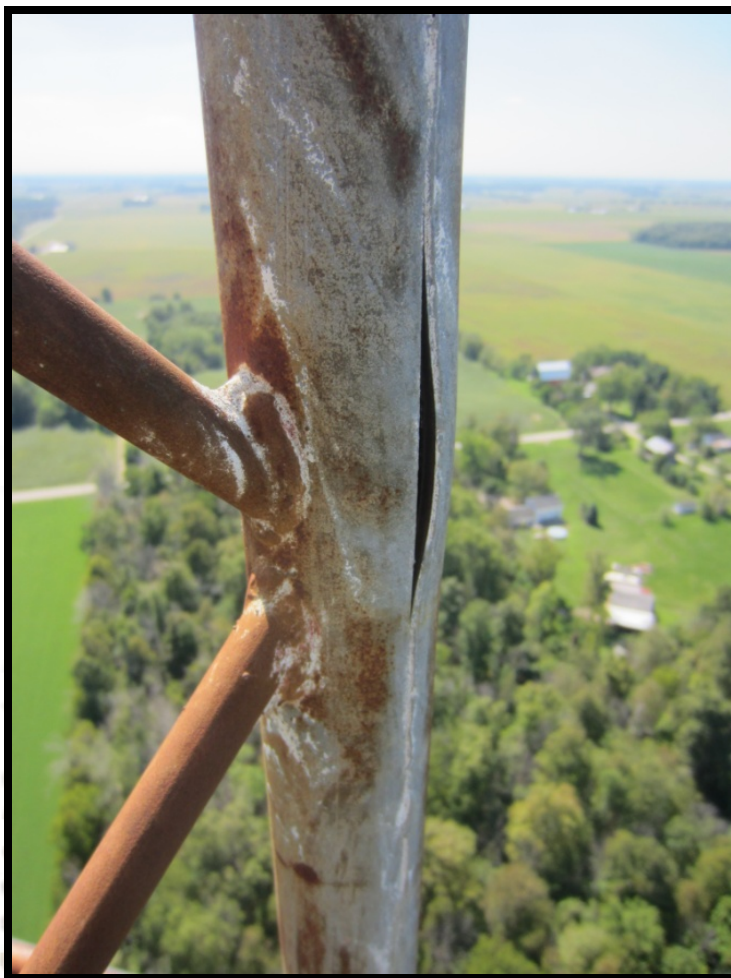
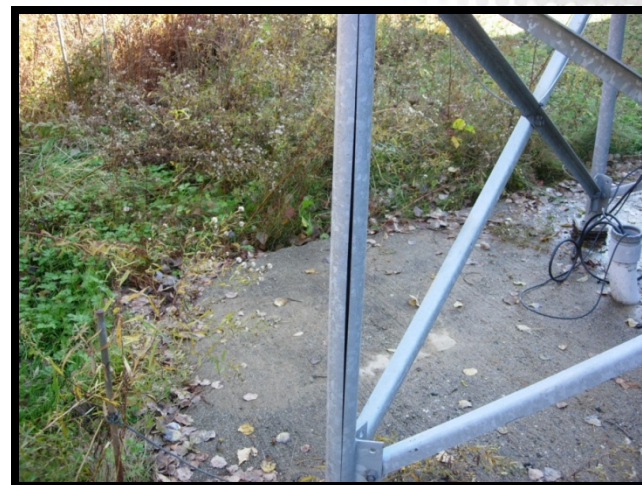
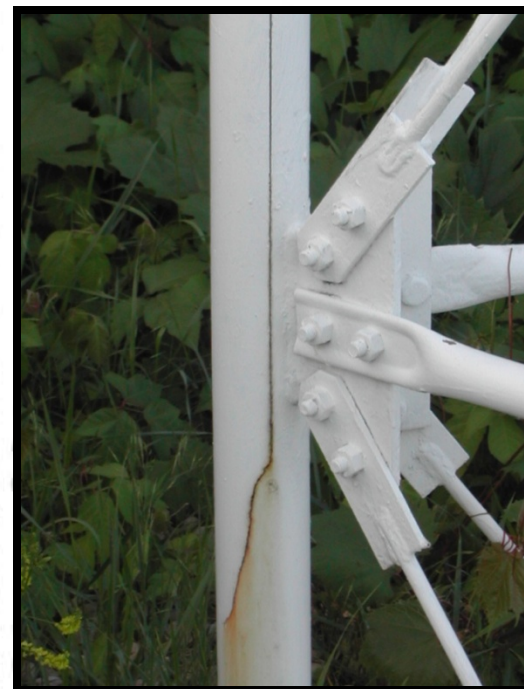
*Freeze/Thaw Damage

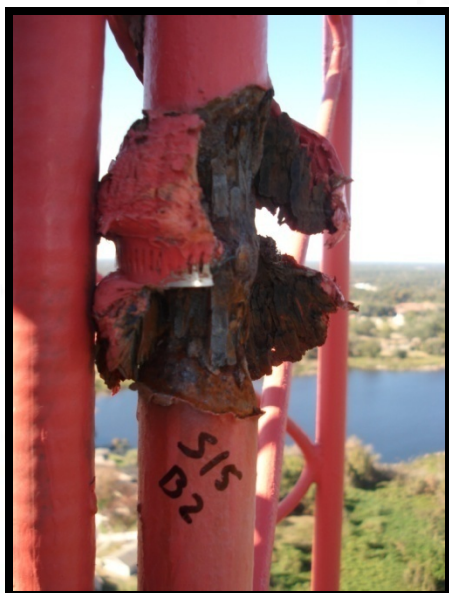
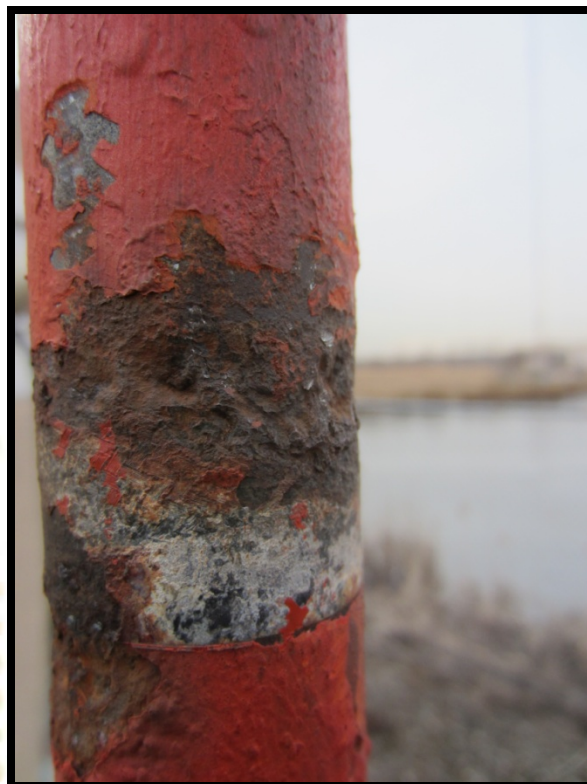
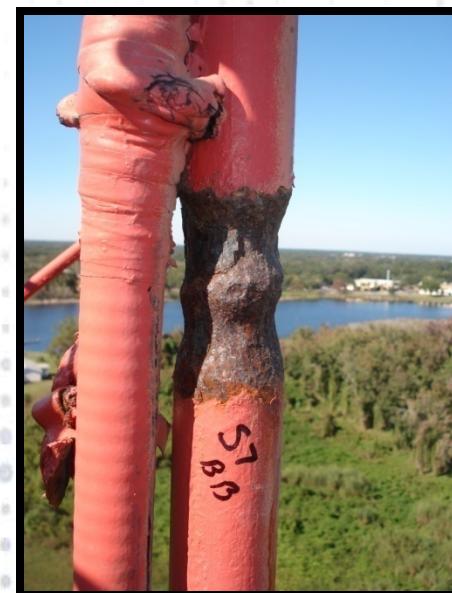
*Relatively Small Amounts of Material Loss Can Be Critical to Member's Load Carrying Capability As Compared to Solid Steel Sections
