Structural Evaluation of Pipe Leg Tower and the Engineering and Execution of Controlled Demolition of Guyed Towers

Presented By: Shawn Knotts
Western Region Account Manager
Electronics Research, Inc.

Subject Project:

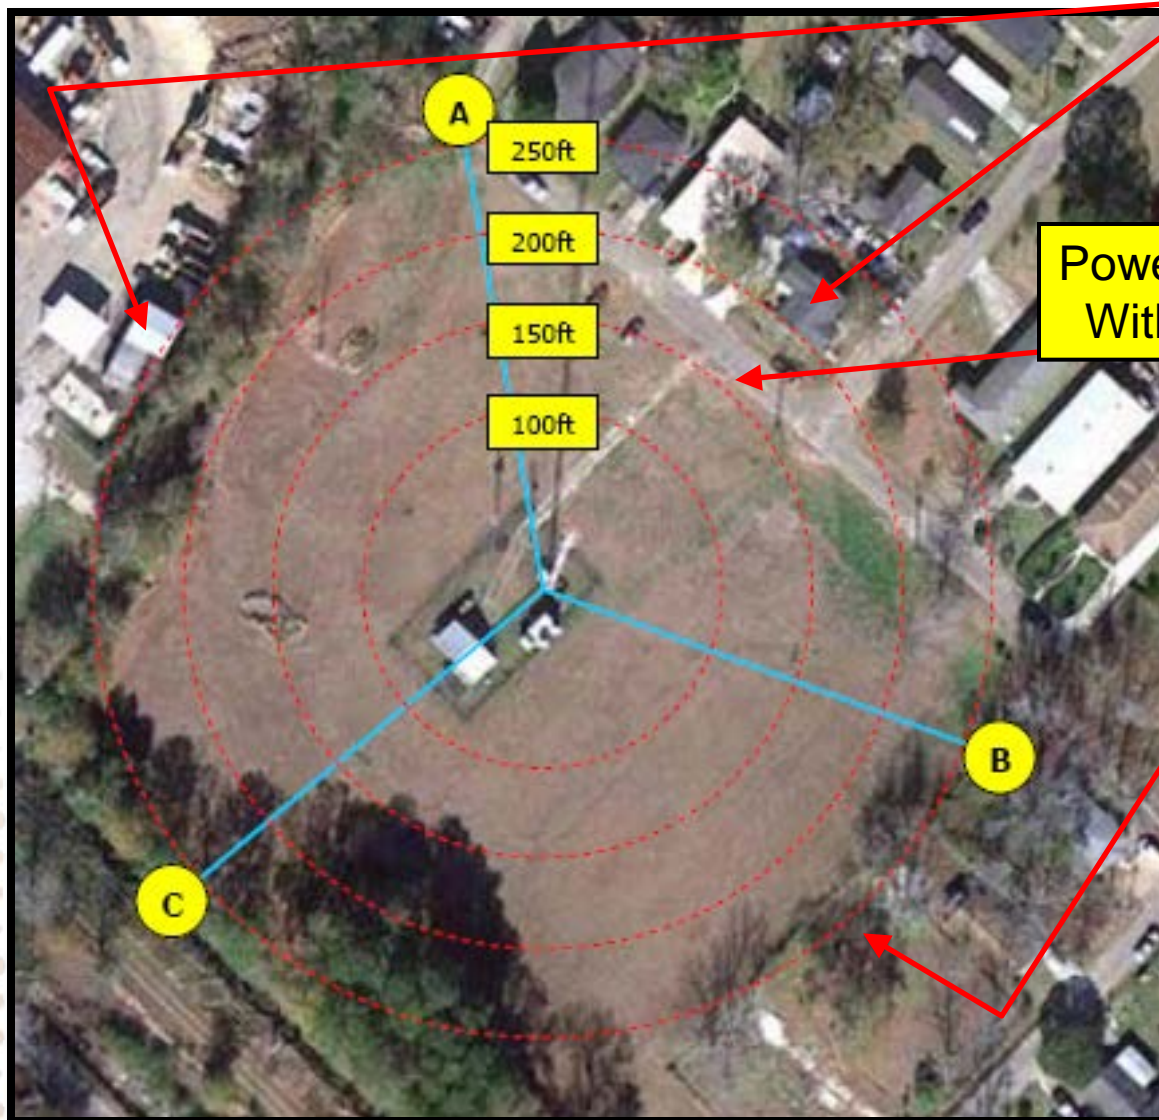
Congested Residential Area:

Homes
Within 200'

Power Lines
Within 150'

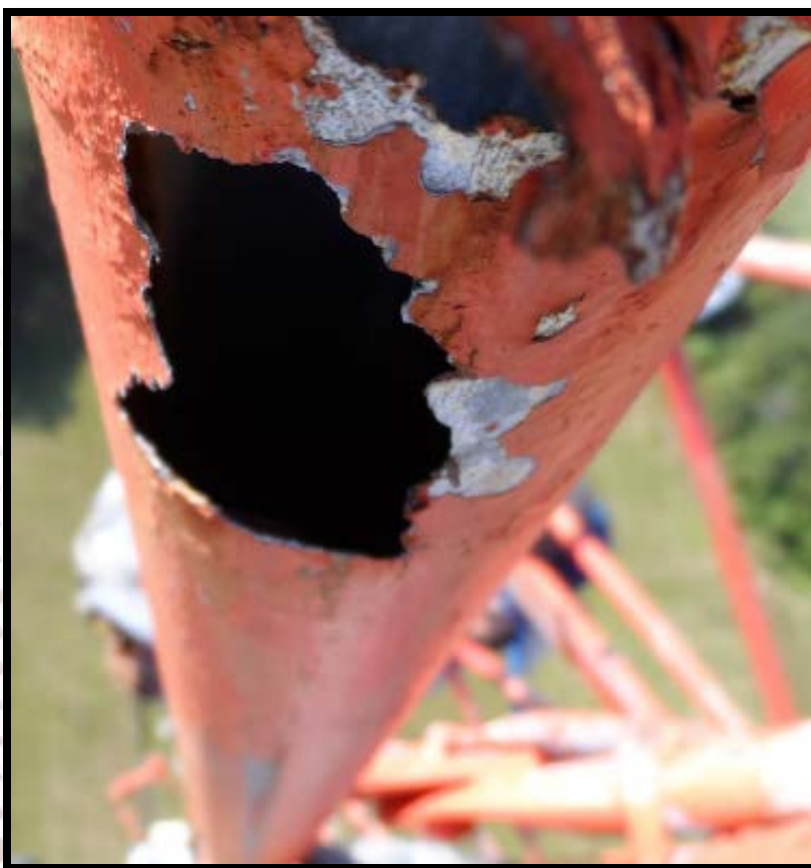
Controlled Demolition Selected:

Structure Could **NOT** Withstand the Minimum Construction Loads for Conventional De-Stack

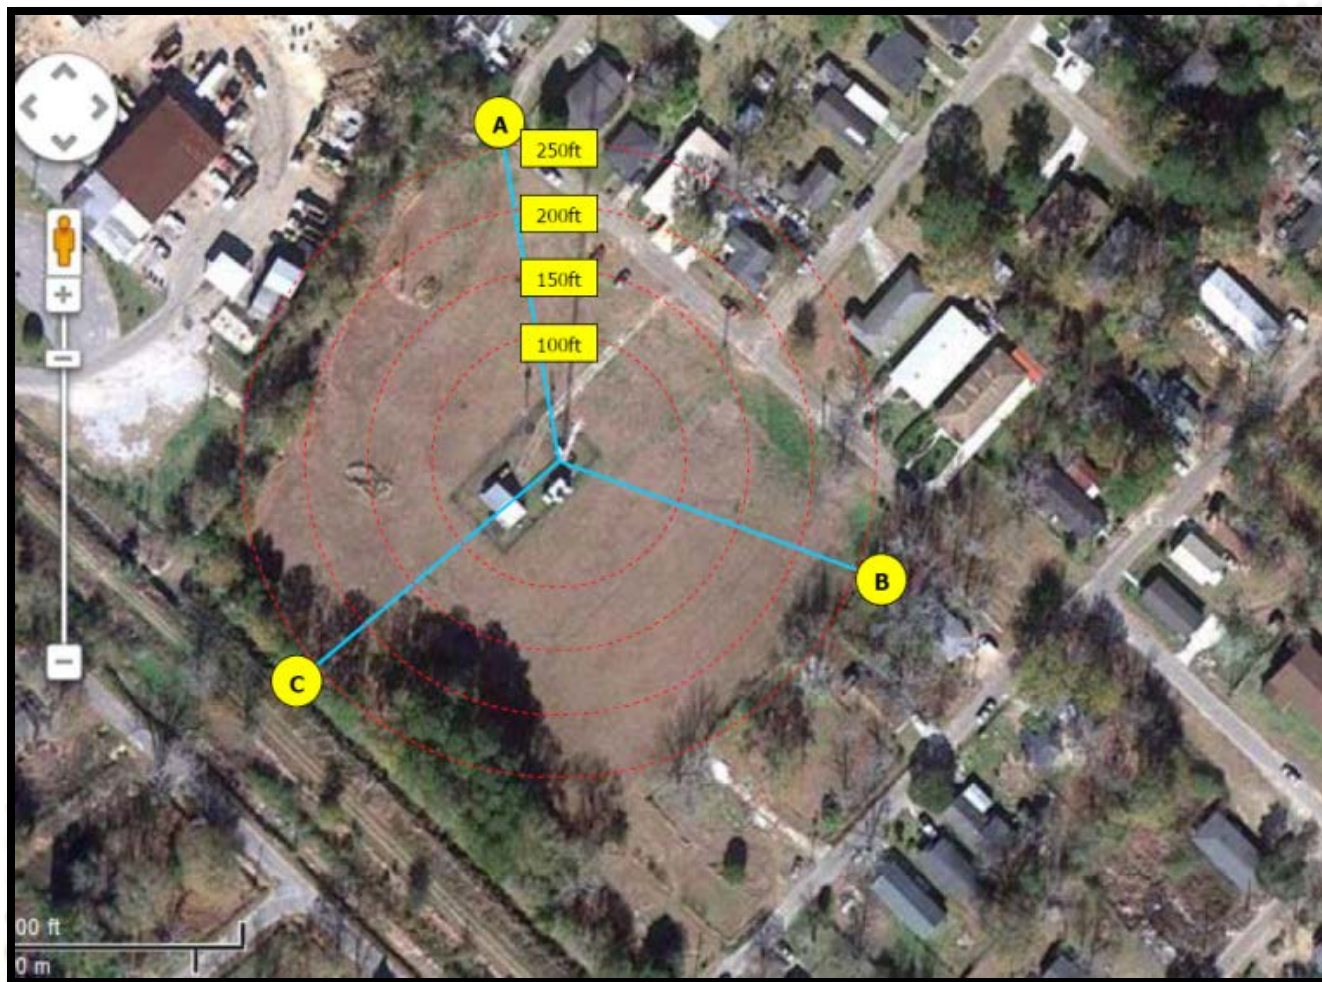
Due to Adjacent Homes, Roads, and Electrical Lines; **Tower Had to Fall Within 150' Radius**

Location of Most Severe Corrosion
Engineered to be First Yield Point
*Direct Fall of Top 180'

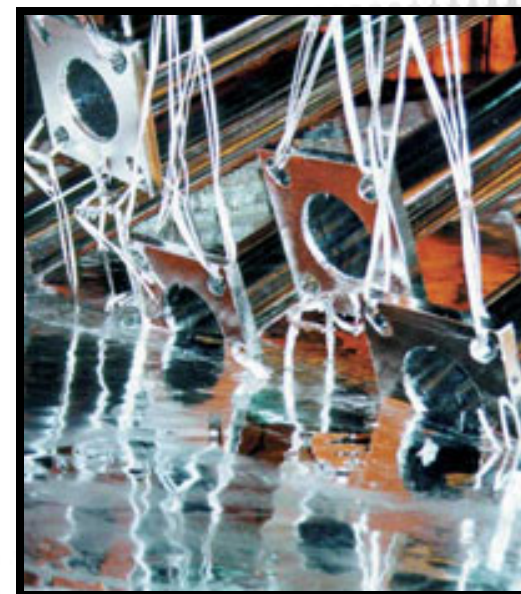
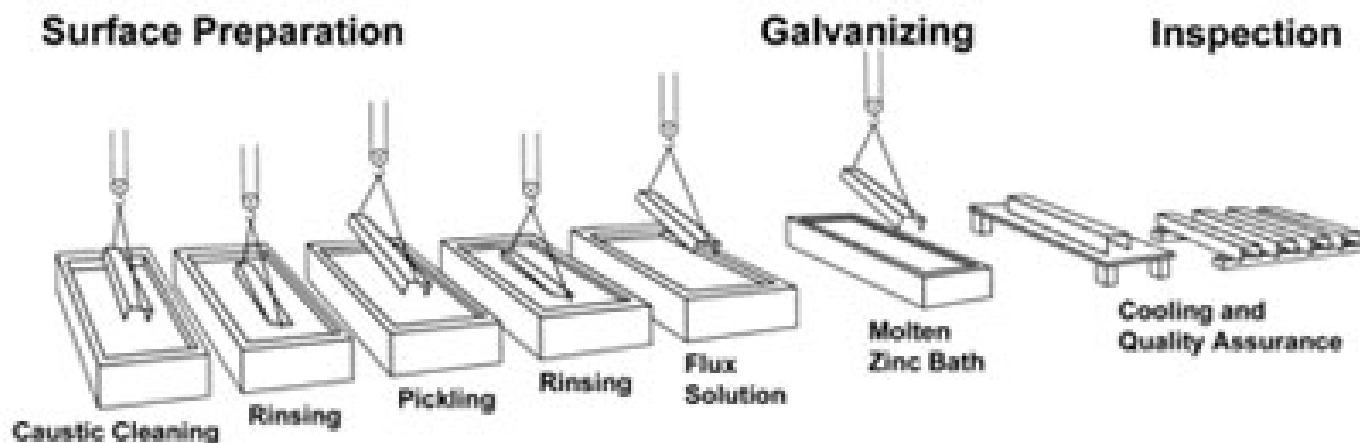
Galvanizing Process:

**Adequate Flow and Drainage is Crucial in Uniform Coatings*

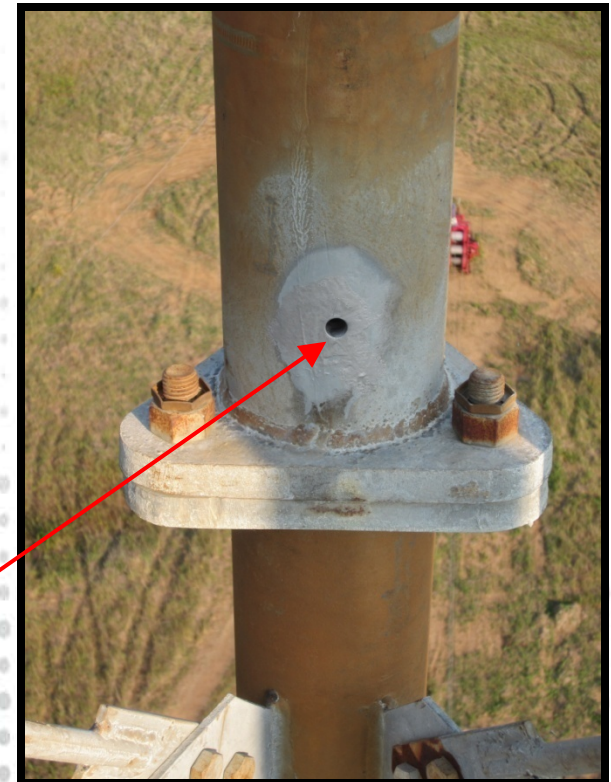
"Weep Hole"

*Ventilation ~ Ensure Pipe's Interior Environment Adjusts Quickly With External Changes in Temperature, Relative Humidity, and Atmospheric Pressure to Prevent Excessive Condensation

*Drainage ~ Ensure Any Accumulated Moisture May Easily Flow Out of Pipe
